Eliminating a Polysilicon Hole Defect Created During Oxide Removal

Ikhoon Shin, Jason Doub, Keith Mortesen, Raymond Lappan
 ON Semiconductor, Pocatello ID USA
Ikhoon.shin@onsemi.com

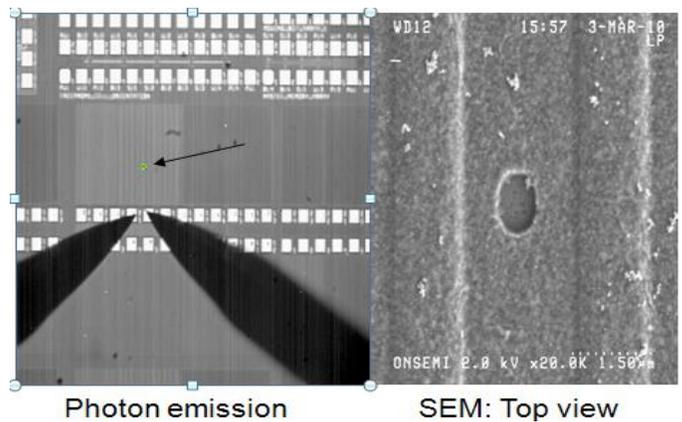
FA (Failure analysis) by photo emission, SEM review, and SEM cross sections showed a round hole in the polysilicon top plate. These polysilicon holes were completely void of polysilicon and typically showed titanium silicide on the sidewalls and hole bottom. Figure 1 and 2 shows a typical appearance of these defects.

Figure 1: Failure analysis work by ONSEMI

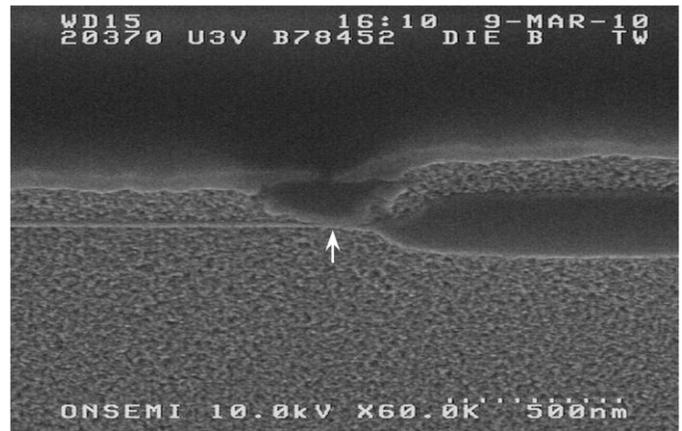
Figure 2: Polysilicon hole with Ti-silicide formation at the bottom of the hole.

While the mechanism remains unknown, the solution of replacing the BOE based pre-metal clean with a 100:1 HF based pre-clean was implemented. Following implementation of this new pre-metal clean, no polysilicon hole defects have been detected with in-line inspections. Additionally, Vramp testing confirmed the D₀ results; HF based pre-metal clean shows improved Vramp performance (Figure 4).

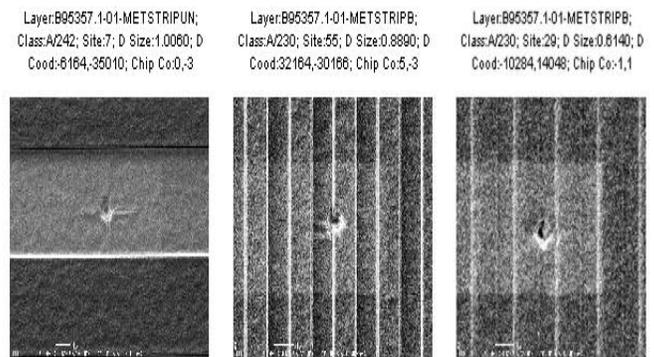
Scans showed that a polysilicon hole like defect was created, but differed in characteristic from the defect under study. The defect not only formed in the polysilicon but also in the Si substrate in the case of high arc current. Also the created defect had the appearance of a typical electrical discharge, and thus was not circular in nature. From these observations, it was thus concluded that the polysilicon hole defects were not due to wafer charging during ion implantation.

Figure 3: Implant charging damage defects at high arc current.

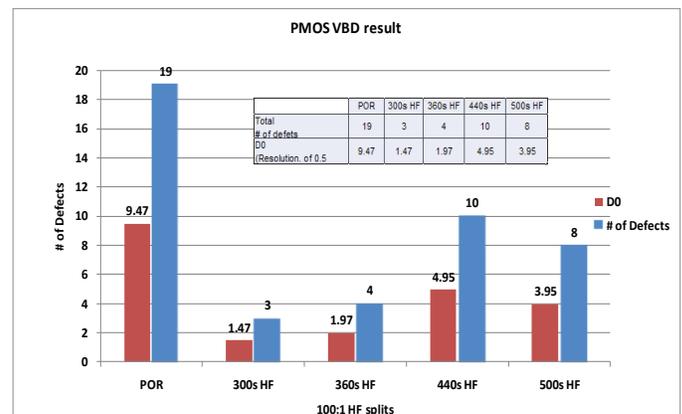
Figure4: VBD result on 100:1 HF
