Design Solutions for Preventing Process Induced ESD Damage during Manufacturing of Interconnects

J. Ackaert¹, B. Greenwood²

1)On semiconductor, Westerring 15, 9700 Oudenaarde, Belgium

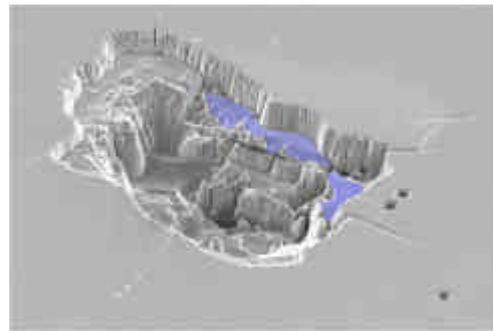
Fig.1: SEM picture of severe defects after an internal ESD event between interconnect networks. The blue are the remain of the metal lines

The nature of the defects as depicted in Fig. 1 points in the direction of ESD like discharge. Therefore the distribution of the surface charging as generated by the via mask process was mapped by means of non contact surface potential measurements. The mapping is presented in fig 9. As can be observed, there is a highly charged location in the centre of the wafer corresponding with the location of the defects. Fractioning of the processes revealed that the water rinsing step is sufficient to generate the defects.

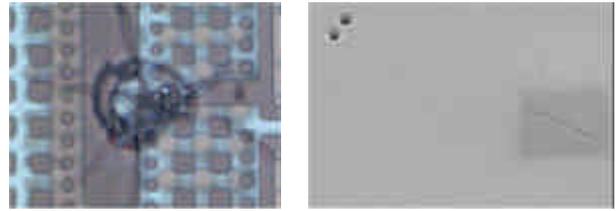
In case of aluminum, the thermal expansion is more than that of the surrounding oxide, while the melting points behave vice versa. In case of an ESDFOS spark, the aluminum immediately melts and expands, while the oxide around suffers cracking. The molten and expanding aluminum, thus generating very small shorts between both top metals, fills these cracks (Fig. 3). A large variation of the severity of ESD events have been observed ranging from large craters in the ILD to minimal cracks: Fig 3.

Fig.3 ESD events that can be observed optically range from large craters (left) to minimal cracks (right)

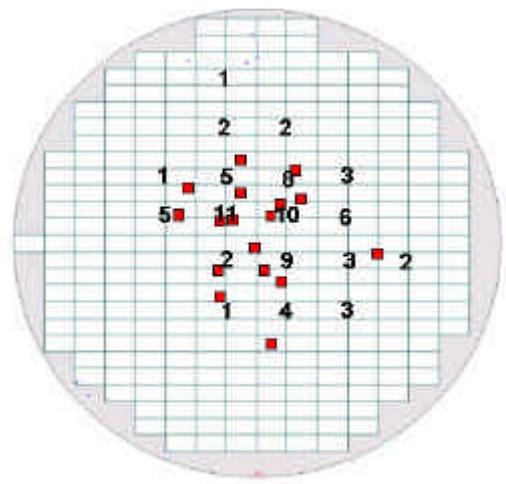
Electrically the events have been detected as a short between the floating interconnect network and grounded metal line. Fig 4 is depicting the location of the optical observations and the location and frequency of the electrical observations. All defects are located in the center of the wafer.

Fig.4: The location of the optical observations and the location and frequency per die of the electrical observations.

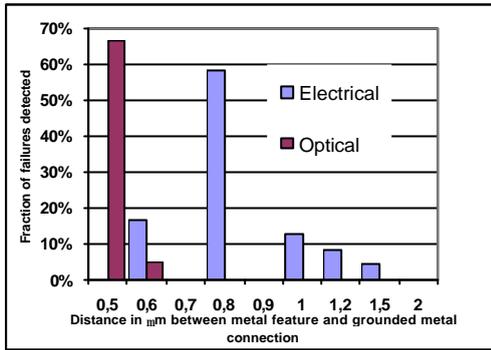
Fig. 5 is depicting the distribution of the defects as a function of the spacing between the networks both for the optical as for the electrical defects. The optically observed events are in general the more severe events that are occur with the smallest spacing. The electrically detectable defects occur at spacing wider then where the EDS events can be detected optically. With severe EDS events sufficient metal has been removed so that chance of occurrence of a metal short becomes very small

Fig.5 The distributions of the optical observations and the electrical observations as a function of spacing between the interconnect networks

The most efficient way to prevent the ESDFOS to have impact on the circuits is to ensure that by design a safe distance is kept between large area floating interconnect networks and networks connected to silicon already. From figure 5 we can conclude that for the given devices processed in the given conditions, 2µm could be considered as a safe distance: No defects have been observed at with a spacing between the networks larger than 2µm. However taking in account that devices that look not affected by the ESDFOS still might show failures

during the lifetime, and extra safety margin needs to be taken in account.

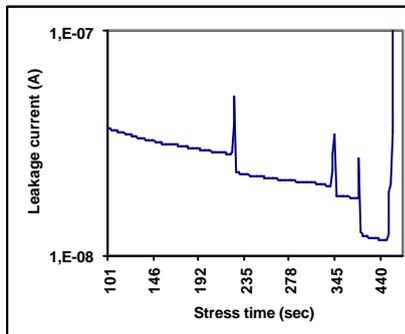
Fig 6 shows the effect of stressing an apparently good device: initial good device may be affected as well and develop an electrical short after stressing. This observation is especially important towards the assessment of impact of the ESDFOS on reliability of a device. Where ESDFOS could be judged as having impact on yield only, this data shows that due to ESDFOS also failures during the lifetime of the device can occur.

Fig.6 An initial good device may be affected as well and develop an electrical short after stressing

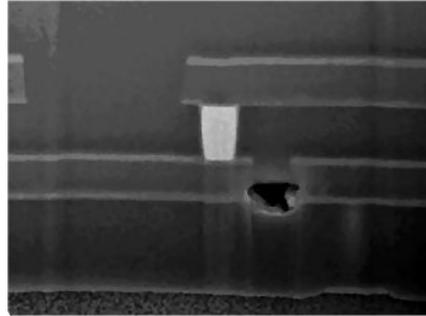
To investigate further on this phenomena, structures that are in between 2 failing similar structures have been analysed by cross section. Fig 7 shows the cross section of an electrical “good” device in the centre of the wafer. Clearly the traces of an EDS event are visible, still there was no electrical or optical signal to detect this device. In the cross section thin metal stringers are visible the can explain the occurrence of the short after stressing the structure as shown in Fig 6.

Fig.7 Cross section of an affected device without optical or electrical observable defect.

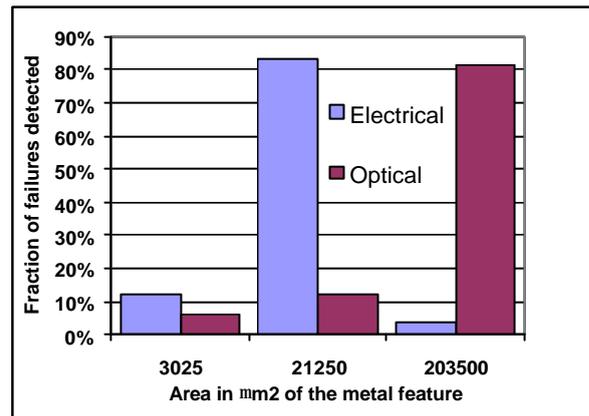
Fig. 8 is depicting the occurrence of ESDFOS events as a function area of the metal feature in the floating network. Larger metal features generate more defects. This area dependence is a clear indication that a surface charging and capacitive coupling is involved in the failure mechanism.

Fig.8 Cross section of an affected device without optical or electrical observable defect.

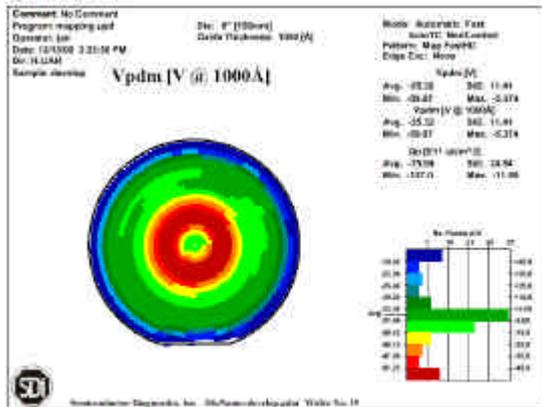
Taking in account the area dependence of the ESDFOS events, the surface charge density has been measured. Fig.9 is showing the surface charges of an oxide layer after spin rinsing in the same process as were the ESD events occurred on the device wafers. The highest levels of charging are measured in the center of the wafer. This is corresponding with the region of the wafer where ESDFOS events have been observed. One could expect, since linear rotation speed, is highest in on the edge, that the edges would be charged most. One should know that the water jet is put on the wafer close to the centre. At the point of contact, the speed gradient between the water in the wafer is highest, causing the highest friction. When moving to the edge, the water takes over the speed of

the wafer surface, in that region, the speed gradient becomes much lower causing less friction and as a consequence, less charging.

Fig 9: PDM mapping of a 1000A oxide layer after a spin rinse process showing -59V charging in the centre ring.

The 59V as measured by the PDM, is too low to cause the observed ESD like defects. One has to realize that ESD type defects are not only caused by the voltage potential but in fact by electric field. In the given circumstances, there is a point shaped conductor in front of a large conductor. Under these conditions, electric field can be increased easily by an order of magnitude [4].
